# COMPREHENSIVE EVALUATION AND MONITORING OF SOLAR THERMAL COMBISYSTEMS FOR DETACHED HOUSES

Alexander Thür and Johann Breidler

AEE Institute for Sustainable Technologies - AEE INTEC;  
Feldgasse 19, A-8200 Gleisdorf, Austria; email: [a.thuer@aee.at](mailto:a.thuer@aee.at)

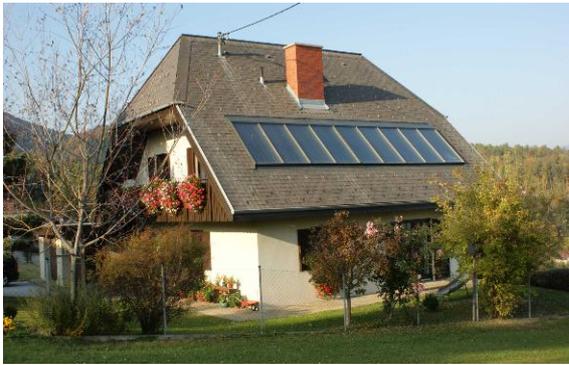
**Fig. 2. Example of a one family house in Austria with a 18m<sup>2</sup> collector on the roof.**

In Fig. 2 an example of a one family house in Austria is shown with integrated flat plate collectors in the roof how it is typically installed in Austria. Fig. 3 gives an overview on the typical sizes of the collector areas versus space heating area of the 70 one family houses which were evaluated within the project.

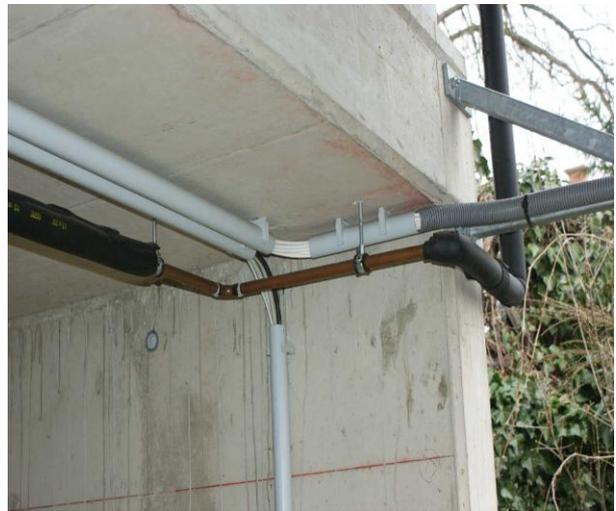
Pipe insulation is often neglected in thermal plants. Inspections showed that this insulation was inadequate in most cases in terms of heat losses but also in terms of protection against UV-radiation and animal bites. The examples in Fig. 5, 6 and 7 illustrate the high potential for improvement in this area.

**Fig.5. Partially missing pipe insulation, no protection against animal bites and UV radiation**

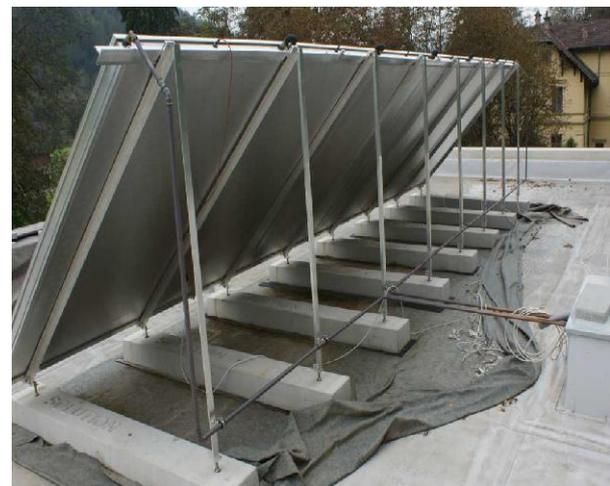
**Fig. 6. Pipe insulation missing from solar circuit external pipes**

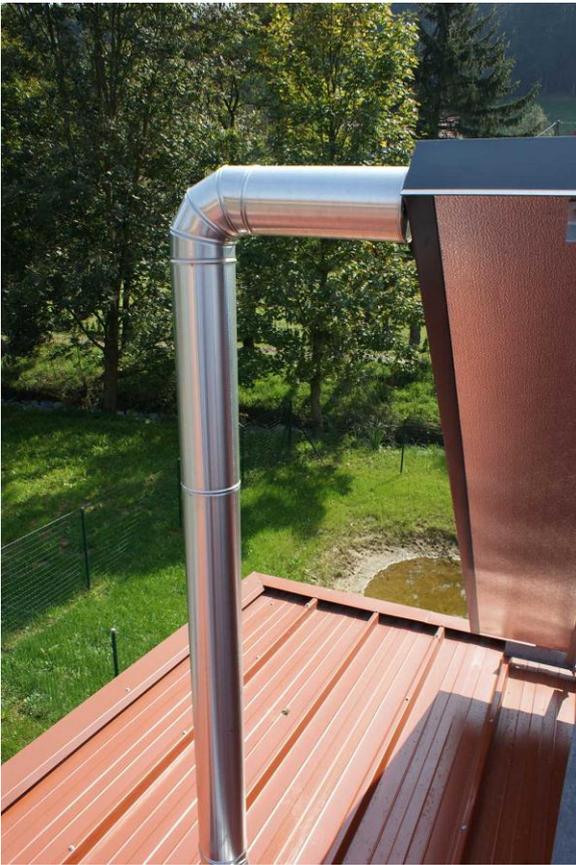
**Fig. 7. Example of good pipe insulation including UV- and animal bite protection.**

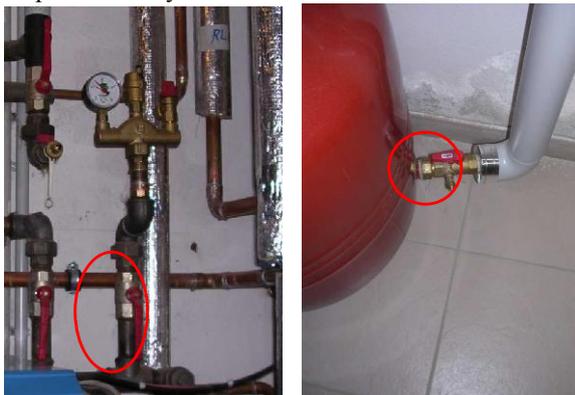
Safety devices such as membrane expansion vessels, pressure control valves and their pressure-release pipes as well as collection vessels for the glycol mix must be fully functional at all times. If, for example, a ball valve is installed in between a safety device and the hydraulic circuit, the functionality of the safety device may be impaired due to unintended blocking. This may cause severe damage to the system. At least the lever should be taken away in order to avoid unauthorized closing of the ball valves in such situations.

**Fig. 8. Pressure control valve (left) and membrane expansion vessel (right): may both be blocked**

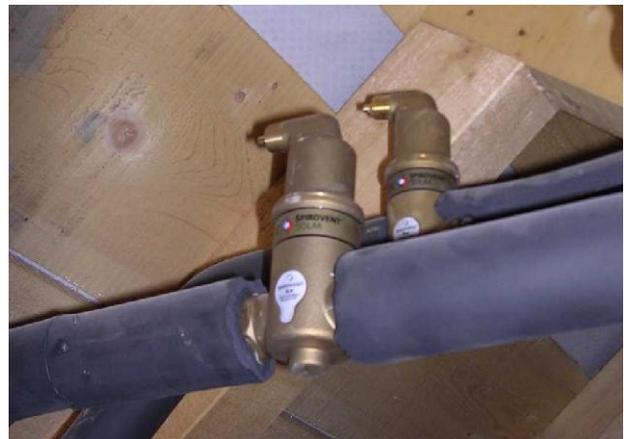
Temperatures of more than 150°C (steam) can be produced near collectors during stagnation. Therefore, all components installed near collectors must be temperature resistant. Air vents installed in close proximity to the steam (during possible stagnation) must not open automatically. Such devices cannot distinguish between air and steam and may drain the plant during stagnation. Fig. 10 and 11 illustrate inappropriate components found near collectors during in-situ inspections, in Fig. 12 a good example is shown.

**Fig. 10. Inappropriate components (automatic air vent) for venting the primary collector loop**

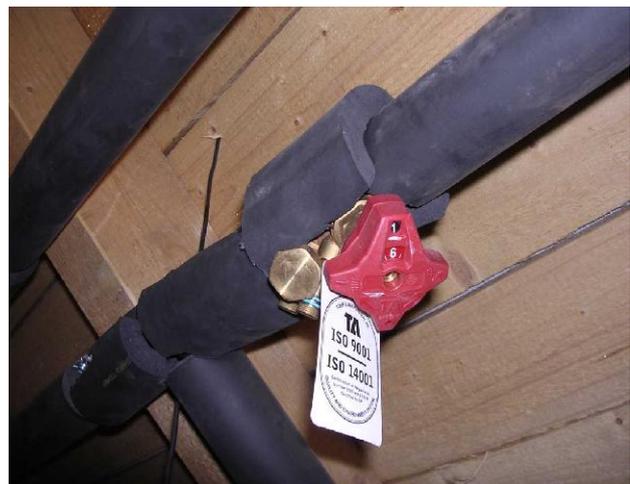
**Fig. 11. Balancing valve near collector does not resist high temperatures**

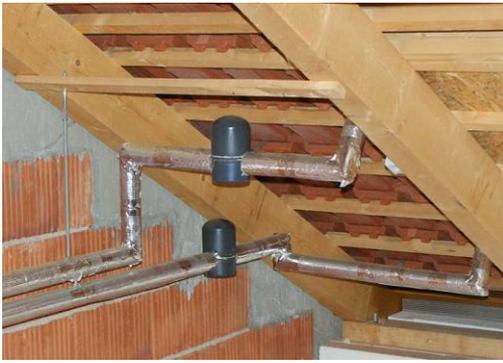
**Fig. 12. Example of correct chosen manual maintained air vents which are insulated and withstand also high temperatures; perfect rock wool insulation of the pipes.**

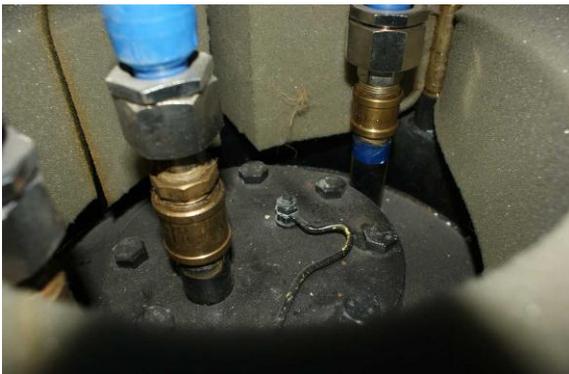
The storage tank is one of the most important components in a solar combisystem. It can only comply with low-loss heat storage if attention is paid to loading (stratification, connection height, etc.) and storage insulation (quality of workmanship, insulation dimensions, insulation of hydraulic connections to the tank, etc.). The inspection showed that most plants lack proper storage insulation as Fig. 13, 14 and 15 show.

It is not only the in-situ installation workers, but also the solar system manufacturers who are responsible for these deficiencies. Companies frequently deliver badly prefabricated storage insulation that is very difficult to mount correctly, i.e. insulation quality is already impaired as a result of the product itself.

**Fig. 13. Very poor heat storage insulation at the top of the tank, which is the hottest place.**

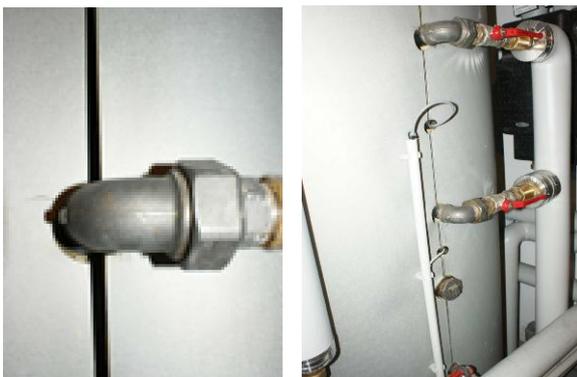
**Fig. 14. Gap in storage insulation (left), storage connections not insulated (right)**

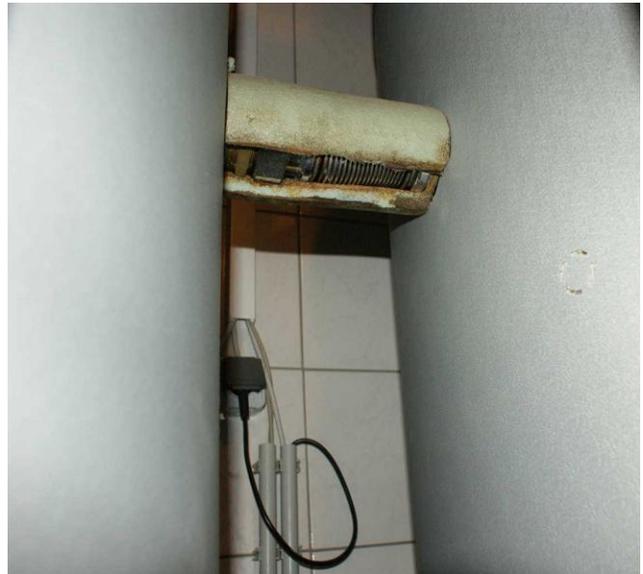
**Fig. 15. Inappropriate insulation material which did not survive the high temperatures which were reached in the heat storage.**

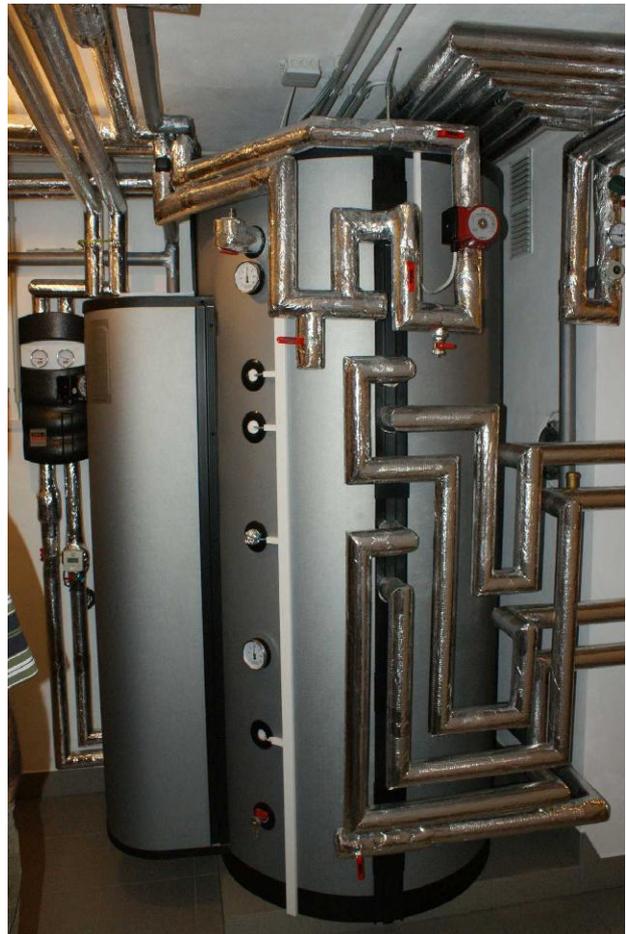
**Fig. 16. Storage tank with exemplary good thermosiphon heat trap installation of the pipe connections.**

One installation element that avoids heat loss due to leakage is a so-called thermosiphon heat trap. Installation of a thermosiphon heat trap at hydraulic connections in 'hot' areas of the storage tank is especially recommended. Fig. 16 and 17 illustrate two positive examples of storage tank insulations.

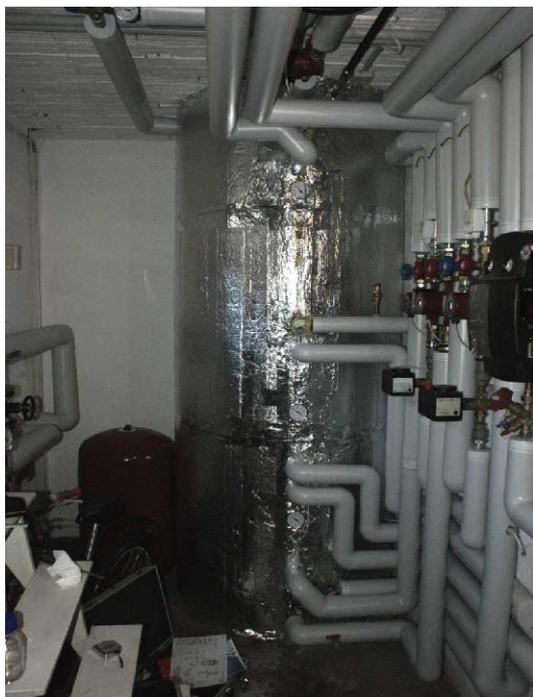
**Fig. 17. Additional insulation on top of the standard insulation, connections insulated up to storage tank insulation**

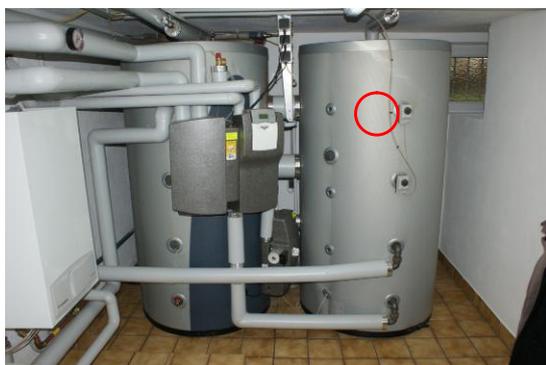
The positions and mounting of the system's sensors were also inspected in the course of qualitative evaluation. Inspection of 20 solar combisystems found frequent errors in the positioning of the sensor responsible for the functionality of the solar heating system, in the bottom of the tank. In these cases the so called dead volume – the volume the solar heating system cannot use – is increased. The position of the sensor for auxiliary heating on the storage tank was also seen to be frequently ill-placed (Fig. 18, 19).

**Fig. 18. Flow pipe connection for DHW preparation from the tank on the left side, but sensor for auxiliary heating of the tanks on the tank on the right side leads to long delay in reaction of auxiliary heating.**

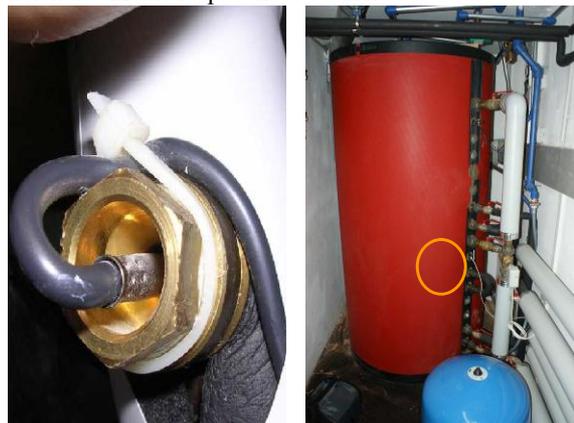
**Fig. 19. Deficient sensor mounting (left) position of 'storage-bottom' sensor too high (right)**

Deficiencies in mounting the sensor on the storage tank were frequently noted. On the one hand sensors are not protected properly from the risk of slipping and on the other, sensors often fail to reach all the way to the end of the immersion sleeve and therefore cannot measure internal tank temperature correctly (see Fig. 19).
