URBAN ELECTRIC RAIL TRANSPORT – 2. EVALUATION OF ENERGY LOSSES DUE TO DEFICIENCIES IN RECTIFYING STATIONS AND ASSOCIATED RAILS OF URBAN ELECTRIC TRANSPORT IN ORADEA CITY

Abstract - In order to optimize the energy consumption, one has analyzed the tram supply network's energy losses from Oradea city. As a result of the studies and determinations carried out, in current conditions, we determined that there are considerable energy losses, not only on the tracks, but also on the distribution elements and the measurement elements of the rectifying stations (power supply).

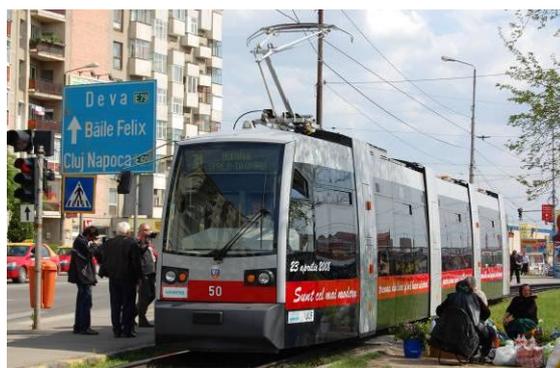
Figure 1. Modern suburban wagons, the last generation - Ulf Siemens type, on the streets of Oradea.

In terms of technology, in 2008 started the acquisition of modern cars (Figure 1. - Ulf Siemens 151 - equipped with converters, induction motors and system for recovering braking energy), measurement contributing both to increased comfort and, especially, the energy efficiency of urban public transport rail; tram traction was done almost entirely driven by DC motors (speed control) with resistance.

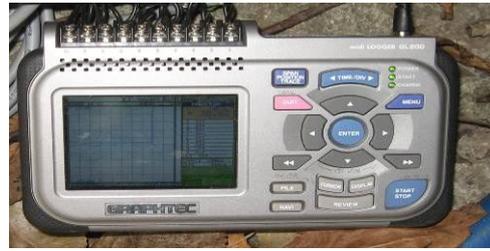
Fig7. Data acquisition and memory tool type GRAPHTEC midi LOGGER GL200

Data was registered with the tool GRAPHTEC midi LOGGER GL200 (Figure 7.).

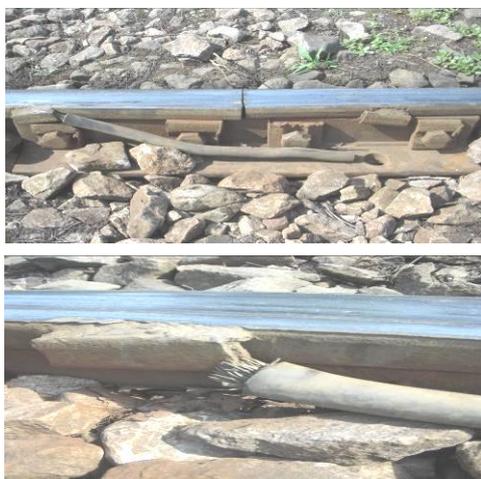
The analysis on the ground rails, it appears that the real values unreasonably high can be explained by the design, implementation and maintenance sometimes running poor routes, particularly the joints between the ends of rails/expansion joints, switches, etc. Thus, in Figure 9. typical images of broken joints are presented; degraded and non-repairable, which leads to excessive increase rolling resistance path.

Fig. 9. Broken joints - sector / loop „Pod CFR”

Given the above, both in terms of reducing specific energy consumption for urban electric rail transport and to minimize damage of steel structures adjacent to the rails by leakage currents "stray" [2, 3], resulting in the

importance of design, implementation and maintenance of rails.
