# EFFICIENCY IMPROVEMENT OF HYDRO-POWER LAKES CAPACITY BY COMBAT THE EXCESS DEVELOPED VEGETATION

#### RADULESCU V.

University Polytechnic of Bucharest, Splaiul Independentei no. 313, Bucharest vradul7@yahoo.com

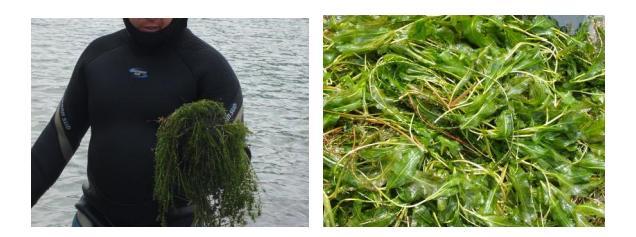
Fig. 1 a, b. Prevalence of samples from lakes - 2006

Into the Fig.1-a, b are presented images during experimental vegetation acquisition. There is no need of any effort to extract vegetation; half meter from free surface is full of vegetation. During the entire year this real "vegetation carpet" is present. In Fig.2- a, b are presented some complex samples, during 2007.

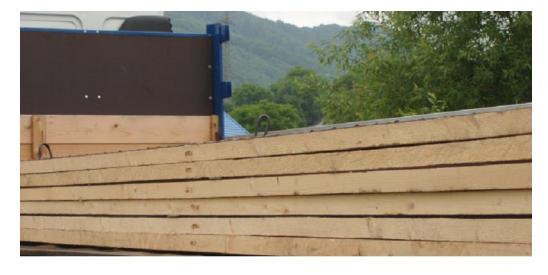
Fig.4. Bottom barrier during transport

Such bottom barrier or benthic barrier covers the sediment as a blanket, compressing the aquatic plants, blocking fully or at least partial the penetration of light. Materials like plastic, black Mylar may be used. In other country there are special material named Texel, a heavy plastic, sometimes used at special roads; nowadays it has a new destination. In Fig.4 is presented one bottom barrier during transport at the established location; the Romanian solution is more compact and easier to be transported.

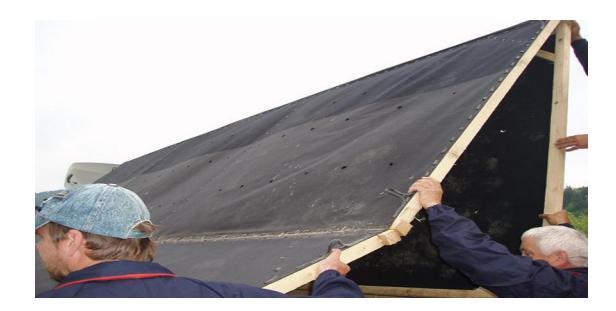
Fig. 5. Bottom articulated barrier

When the barrier is placed over vegetation, to be sure that it is not moved by the natural current of water or by different birds or animals it must be anchored at corners and at least into another six places. To decrease the final costs as anchors we put some local stones into some special realised recipients. Into Fig.5 it is presented the barrier. To be efficient it must be from black or any way dark material to assure the impossibility of penetration of light; the selected material was a solid plastic, used in construction.

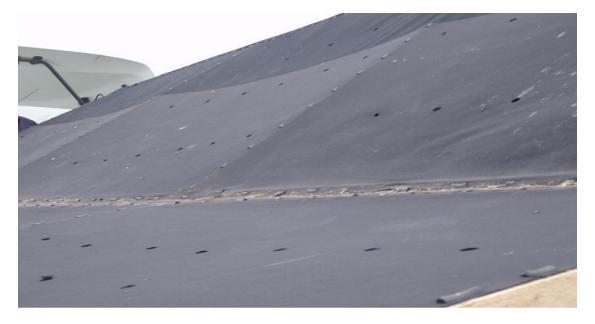
Fig.6 – The new solution of barrier

Each barrier must rests into the same place 3-4 weeks. During this time a lot of cases (produced by vegetation covered by this barrier) must be evacuated. First time when we tried the barrier was completely destroyed by the produced gases. To avoid second time we execute many holes, Fig.6; time proved that the adopted solution is a correct one.

The divers moved the bottom barrier. Due the realised holes the emanated gases during dying vegetation and decomposition were evacuated. In to the first time the gases realised some spaces full of gases which finally destroyed the material of barrier. Now they are almost as new.

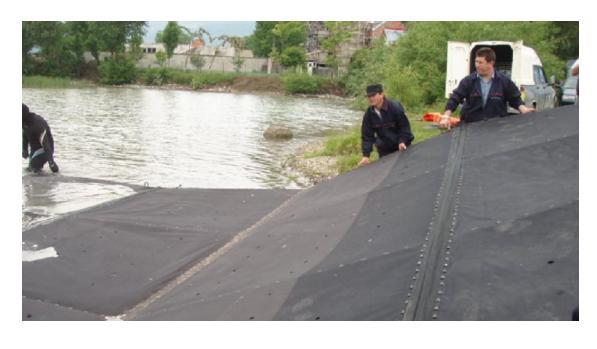
Fig.7. Image during implementation

This method of combat the excess developed may to be used even from the beginning of the vegetation, earlier into March till end of November. In Fig.7 is presented an image during transport at to the selected area of first implementation. Into hydropower systems, the massive vegetation appears at small water, till 4-6 m, all around.

The transport was carried by a boat and two divers.

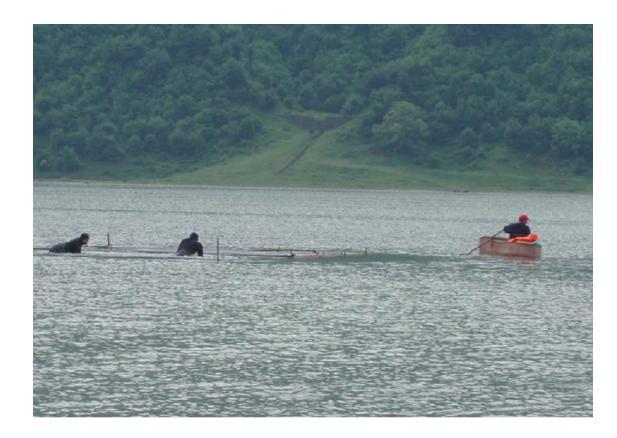
Fig. 8. Image during installation

Any other tested solution during time was not efficient; the chemical solution is not possible due to water supply, the biological solution was inefficient due small temperatures, the mechanical tested solution was a real disaster. Entire team hopes that the barrier will be a real solution. In Fig.8 is presented an image during installation of the system of anchoring of bottom barrier.

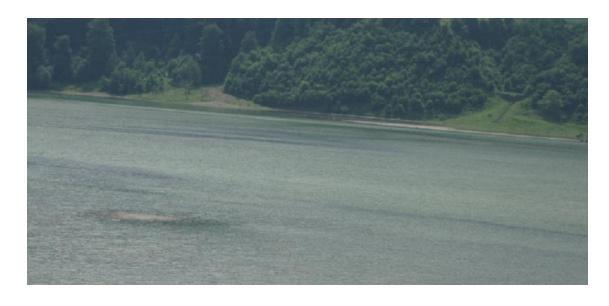
Fig.9. One week after installation

After one week a team verified the place where the barrier was placed. The firs photo was made, Fig.9. Already it may be observed that into the barrier area the vegetation change his colour. It doesn't grows it doesn't develop like into other places.

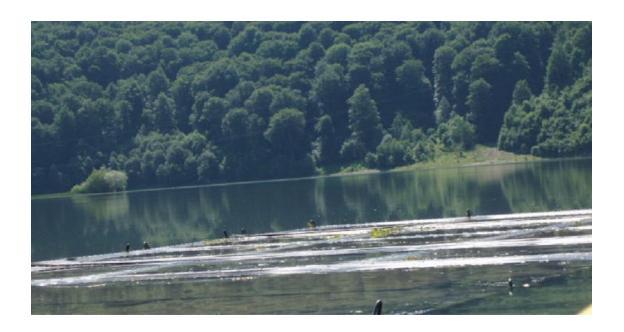
Fig.10. Image during movement to a new location

In June the barrier was transported into another location. Once anchors removed it floats at the surface, Fig.10. The divers move it carefully, not far away the first implementation, just to have an answer of question of influence area of the barrier. The entire team was curious of the efficiency of the solution.

It may be observed that through his holes appears developed vegetation. When the divers tried to collect the rests they observed that's impossible. The vegetation is partially destroyed. In Fig.11 is presented an image with vegetation collected from vicinity of the bottom barrier.

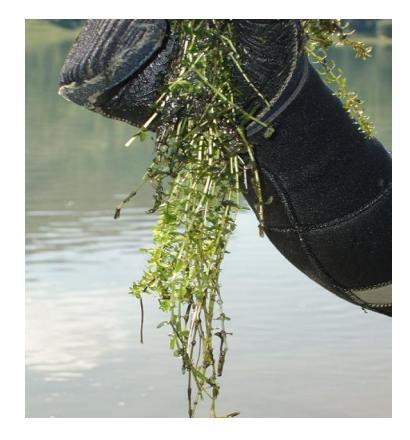
#### Fig.11. Collected vegetation near vicinity of barrier

At it may be observed from the picture the vegetation has no roots. Partially it is destroyed. The colour has already changed his aspects; it is not full green as a month before, there are many places where it became brown due disintegration.

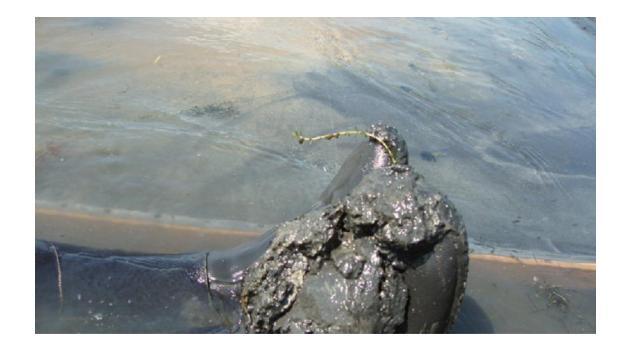
Fig.12. Mud collected

The divers returned to the place where it was first installed the barrier and try to collect some samples; t*here were no vegetations*, Fig.12, Fig.13.

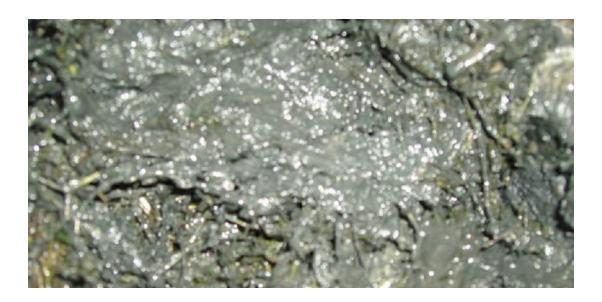
Fig.13 a, b. Collected mud under the barrier

Into the place where the barrier was anchored there was no vegetation. After a month all types of plants, due absence of light and excessive temperature developed under the plastic material of the barrier. Even few meters all around the bottom barrier the vegetation is partially destroyed. The place where the barrier was installed was market to may be observed into the next year to see if the vegetation reappears.

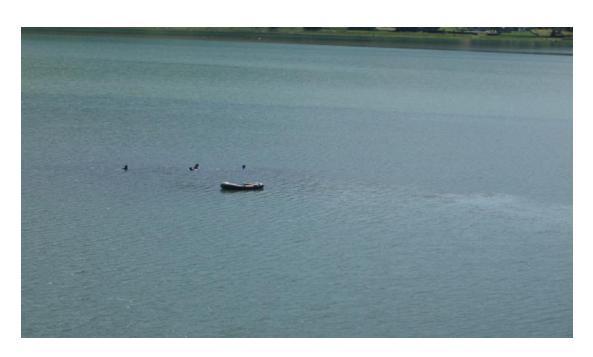
Fig.15. Dark spot of the macerated vegetation

From the Fig.14 it may be noticed as viewed from distance that place where the barrier was places the spot is darker, due to vegetation destroyed (macerated).

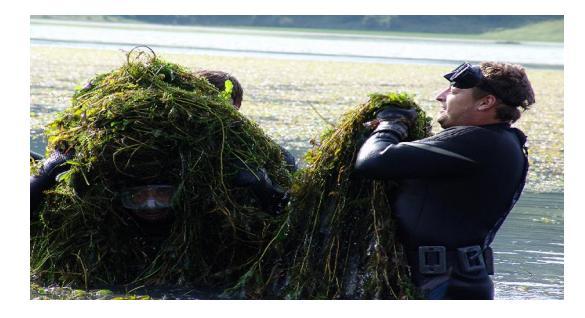
Fig.16. Developed vegetation into normal conditions

In July the barrier was transported into a new location far away from the first tested area. In Fig. 16 is presented an image with developed vegetation with free surface, as before.

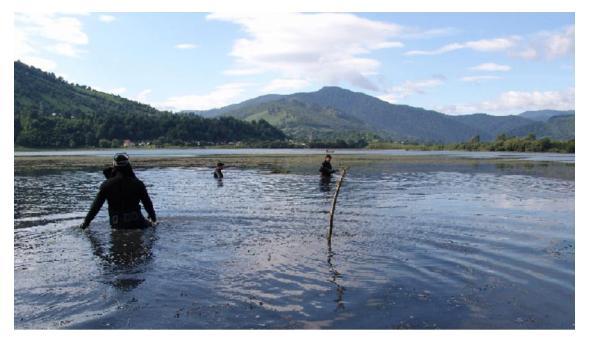
Fig.17. Place partially cleaned by vegetation

Finally is presented an image of the first place where the bottom barrier was installed, after two months.

The area where the bottom barriers were implemented was observed and during 2008-2010. Generally we may appreciate that the "treated area" now is partially released by vegetation.
